SPRING RIVER PARK AND ZOO

EXISTING CONDITIONS & DESIGN RECOMMENDATIONS

FINAL REPORT - JANUARY 2018

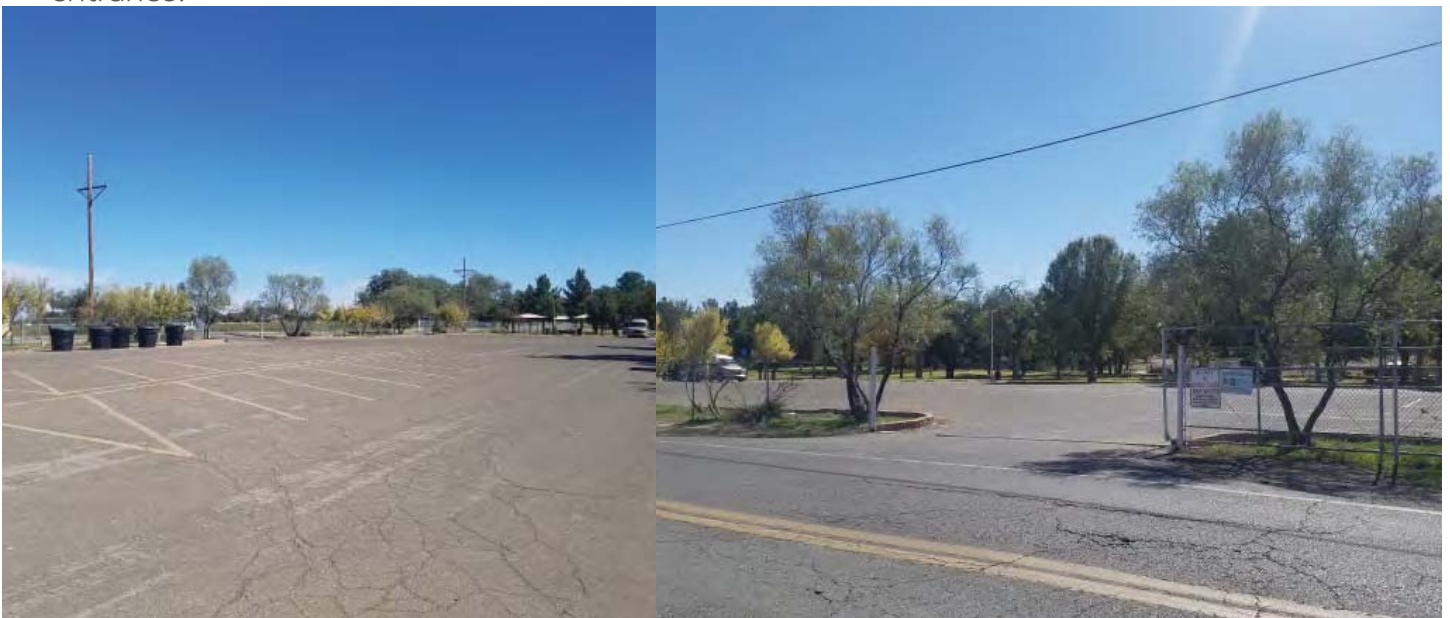
- The asphalt, while worn, is in adequate condition.
- There are no islands or trees in the parking lot. Shade is limited to the southern most row of parking where cars can benefit from the trees in the existing park.

Parking lot is too bright and hot during the summer months. Entry to lot is underwhelming.

- Consider whether re-organizing the existing north parking lot will increase the number of available spaces.
- Avoid building permanent structures or planting too many trees in the park area east of the existing north parking lot where future expansion of the parking lot may be warranted. Consider relocation of the picnic activities in this area as equipment becomes due for replacement.

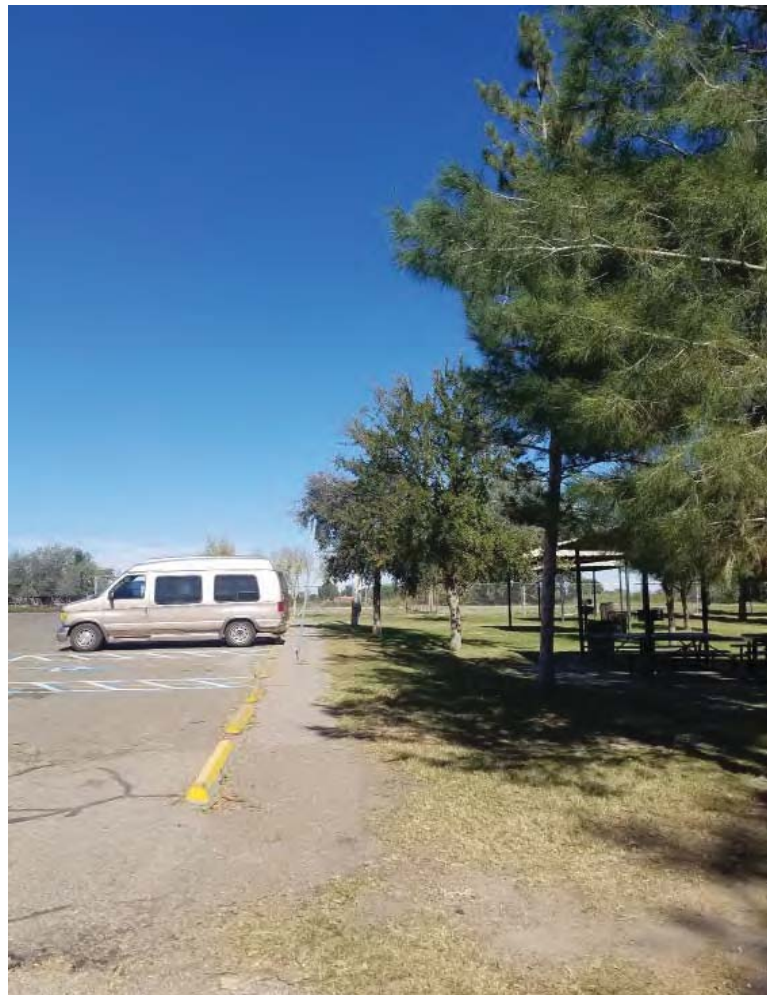
- Several accessible parking spaces are provided on the east side of the north parking lot, next to several shade structures with picnic tables. There is not an accessible sidewalk between the parking area and the shade structures, inadequate space to maneuver is provided around the structures and to the tables, and the tables are not designed to accommodate a wheelchair user.

There is no accessible path from the ADA parking spaces to the adjacent picnic area feature.

- Construct a new, accessible group picnic area on a concrete plaza with accessible tables and an accessible route between the plaza and the parking lot. Relocate this feature so it does not conflict with future parking expansion.
- When replacing playground equipment, verify that new equipment meets the current standards for accessible access and number of play opportunities. Ensure an accessible route is provided from the parking area to the playground.
- Review and provide the appropriate number of accessible parking spaces.
- Relocate some of the existing benches so that they are immediately adjacent to existing paths and can be used without crossing the turf.

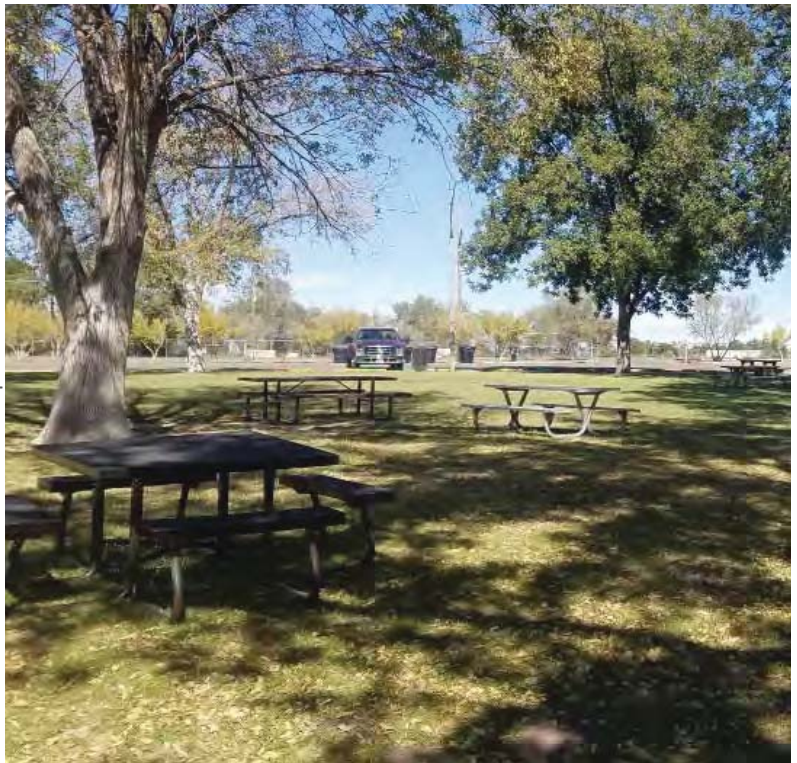
A generous number of site furnishings can be found in the park, however none can be reached by an accessible path.

- Benches, tables and trash receptacles are quite numerous and are generally in good condition. The equipment ranges from wood, to galvanized to vinyl coated and are scattered throughout the site. Most furnishings are located in turf, making them difficult to mow around and at risk of damage from irrigation spray and trimming operations. Few furnishings can be accessed by an ADA accessible path.

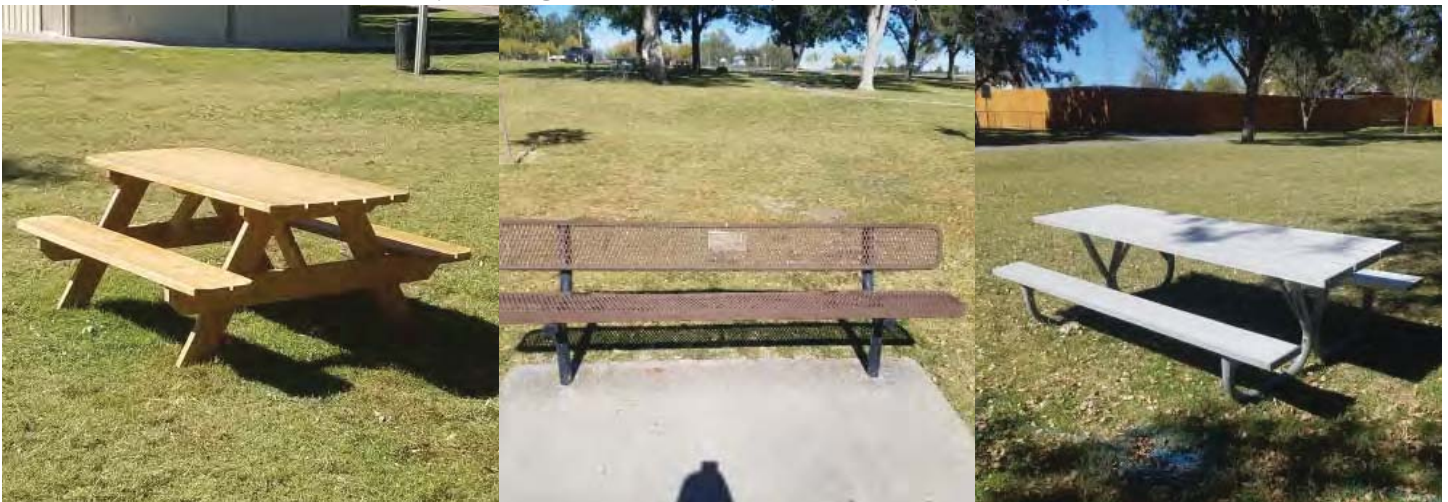
Choose one style of site furnishing. Avoid wood and vinyl coated furnishings, they do not last in our climate.

- Consolidate multiple shade structures into one large structure that can be easily made accessible and will accommodate group activities. Smaller, single family structures can be scattered throughout the park. Powder coated steel structures with a metal roof are the longest lived and can be found in a variety of colors.

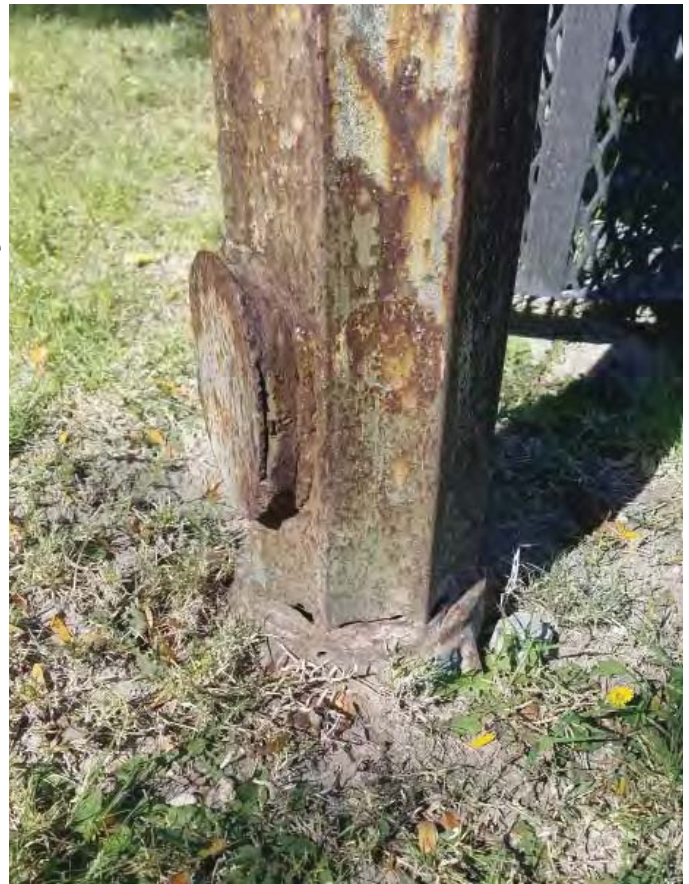
- A number of light poles can be found throughout the park, some of which are missing their wiring access covers which would allow the public to come in contact with the wiring. The lights are not located consistently throughout the facility and the poles are quite rusted.

Site lighting is past due replacement.

- Lighting recommendations are dependent on future use of the site. Currently the facility is closed at night with access limited to a few special events throughout the year. Nighttime events should be reviewed and at a minimum paths and gathering areas should have a level of light adequate to allow for safe walking and personal security.

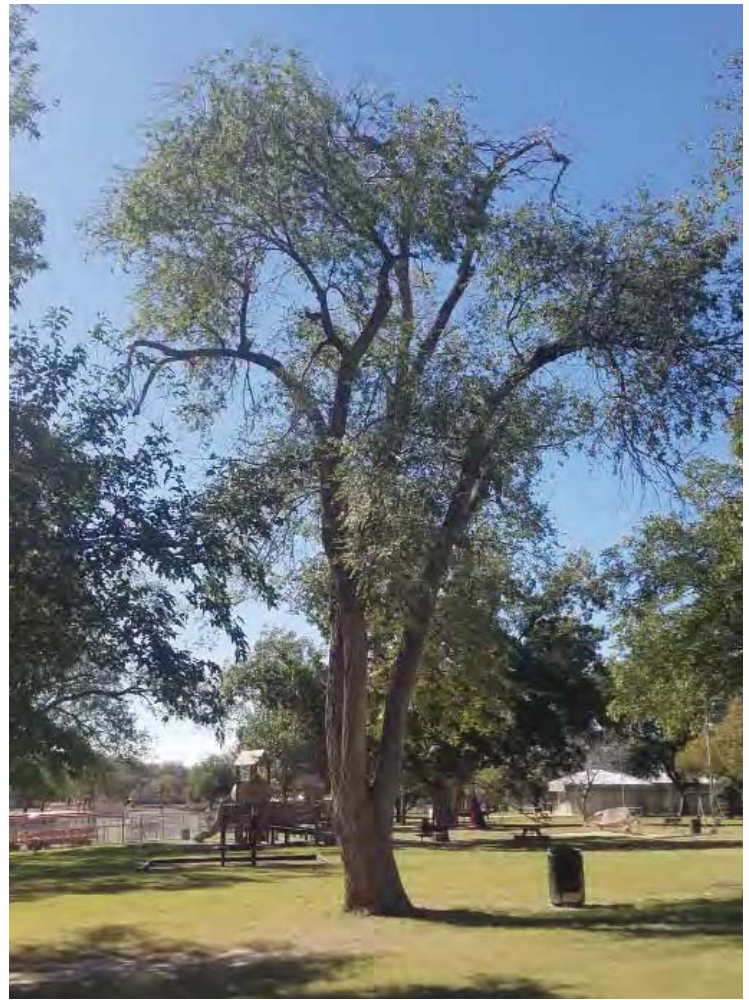
Mature trees are beginning to decline. This tree will begin to drop large limbs and will require removal in the next few years.

Begin a tree planting program by installing +/- thirty trees a year over the next ten years. Trees should be at least 2" caliper to create an immediate impact and withstand pressures of being in a public park. Plant no fewer than ten species each year and plant at least 25% evergreens.

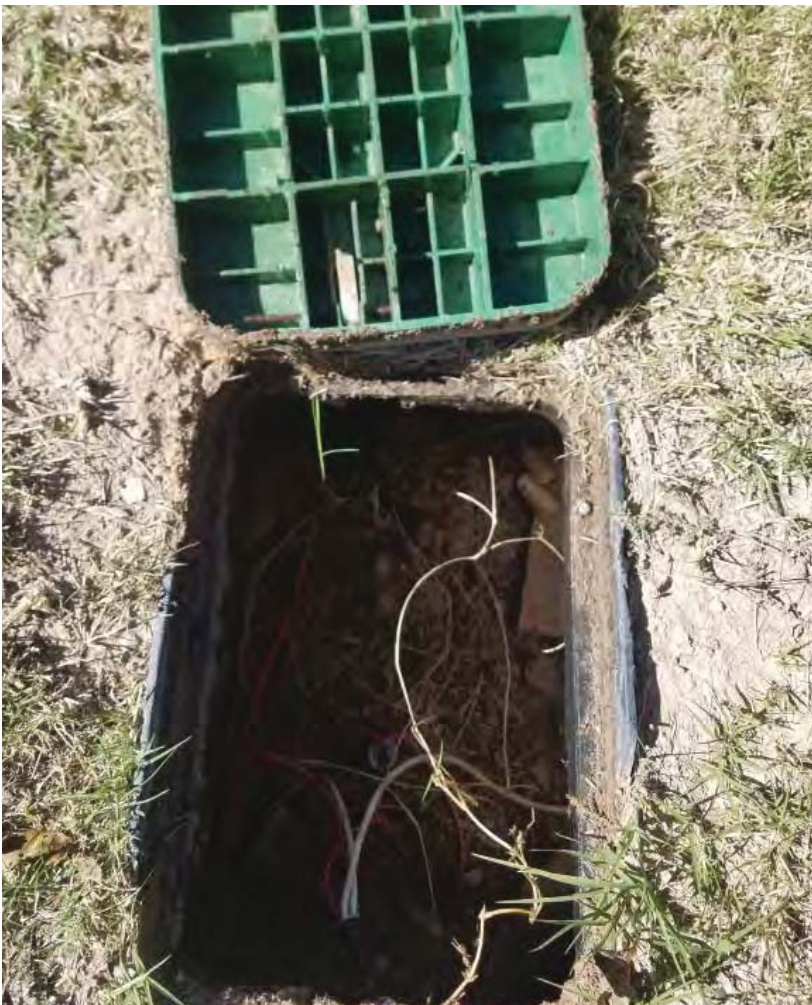
- Overall, the irrigation coverage appears adequate with few to no dry spots visible on aerial imagery.
- Anecdotal information from staff indicates that the system is quite old and documentation does not exist that maps the system in its entirety.
- Pressures are reported to be low. Rather than installing a booster pump, staff is under sizing pipe to increase throw.
- No backflow preventor exists as the system is well based, however potable water is used as a back-up and is reported to not include a back-flow prevention device.
- Valve boxes are undersized and it is not feasible to repair valves without removing the box itself.

This existing valve is buried in debris and impossible to access. To replace or repair the valve, the entire valve box would require removal. It is very likely that no mechanism exists to remove the valve without shutting down the entire irrigation system.

- Audit the existing system and create a map of the existing system.
- Create an irrigation master plan taking in to account the available flow and pressure from both the well and the potable water system. The design should take into account the existing and future irrigation needs of the facility.
- Install a backflow preventor on the potable supply and install booster pumps on both systems as required to produce adequate pressure.
- Create a list of standard equipment and installation details for the irrigation system and begin implementing the standards on both new construction and repairs to the existing system. Standards should be applied across the City's park system.

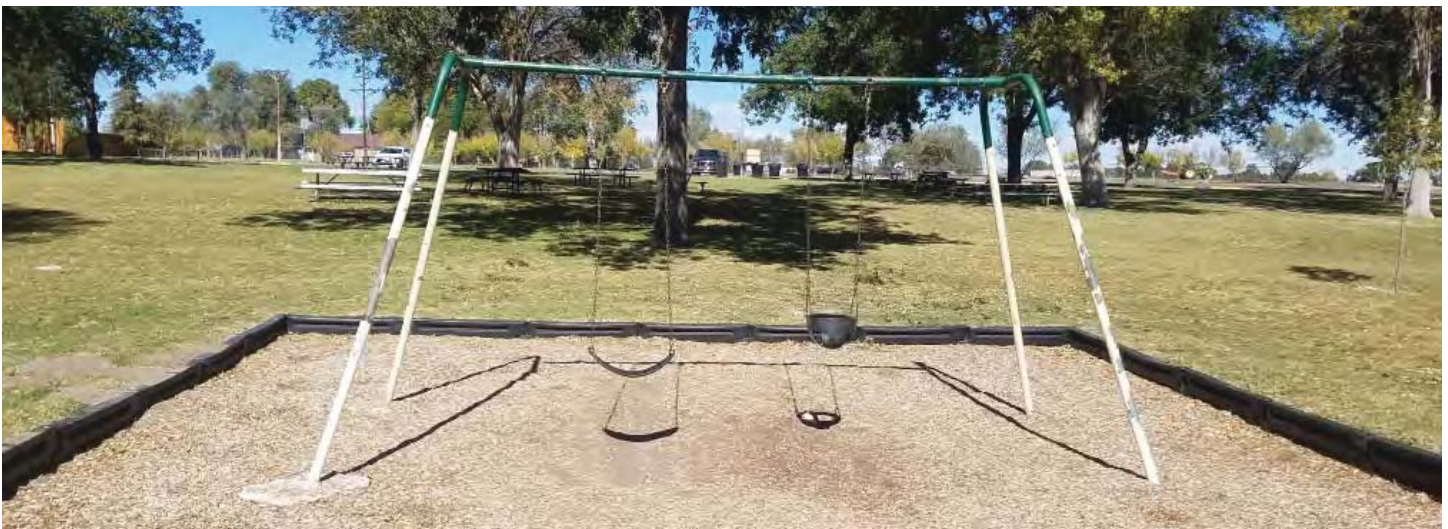
- **Swings:** The swings have two bays, a standard strap seat and a toddler bucket seat installed over engineered wood fiber with a plastic border. The condition of the equipment is worn but usable. Plastic border is in fair condition. Engineered wood fiber has deteriorated and settled, exposing the concrete footings and creating a safety hazard.

Note the exposed concrete footing. Engineered wood fiber should reach the top of the plastic border.

- A playground safety audit should be performed annually by a CPSI certified auditor, for all playgrounds owned and operated by the City. Safety standards are updated on a regular basis and following the recommendations of the audit can protect the City from serious liability. It is also possible for a City of Roswell employee to become certified and to perform audits internally. The audit will make recommendations for removal, repair or modification to equipment as well as verify safety zones and surfacing requirements. It is important to note that some safety hazards are subtle and the observations included in this report do not constitute an official audit.

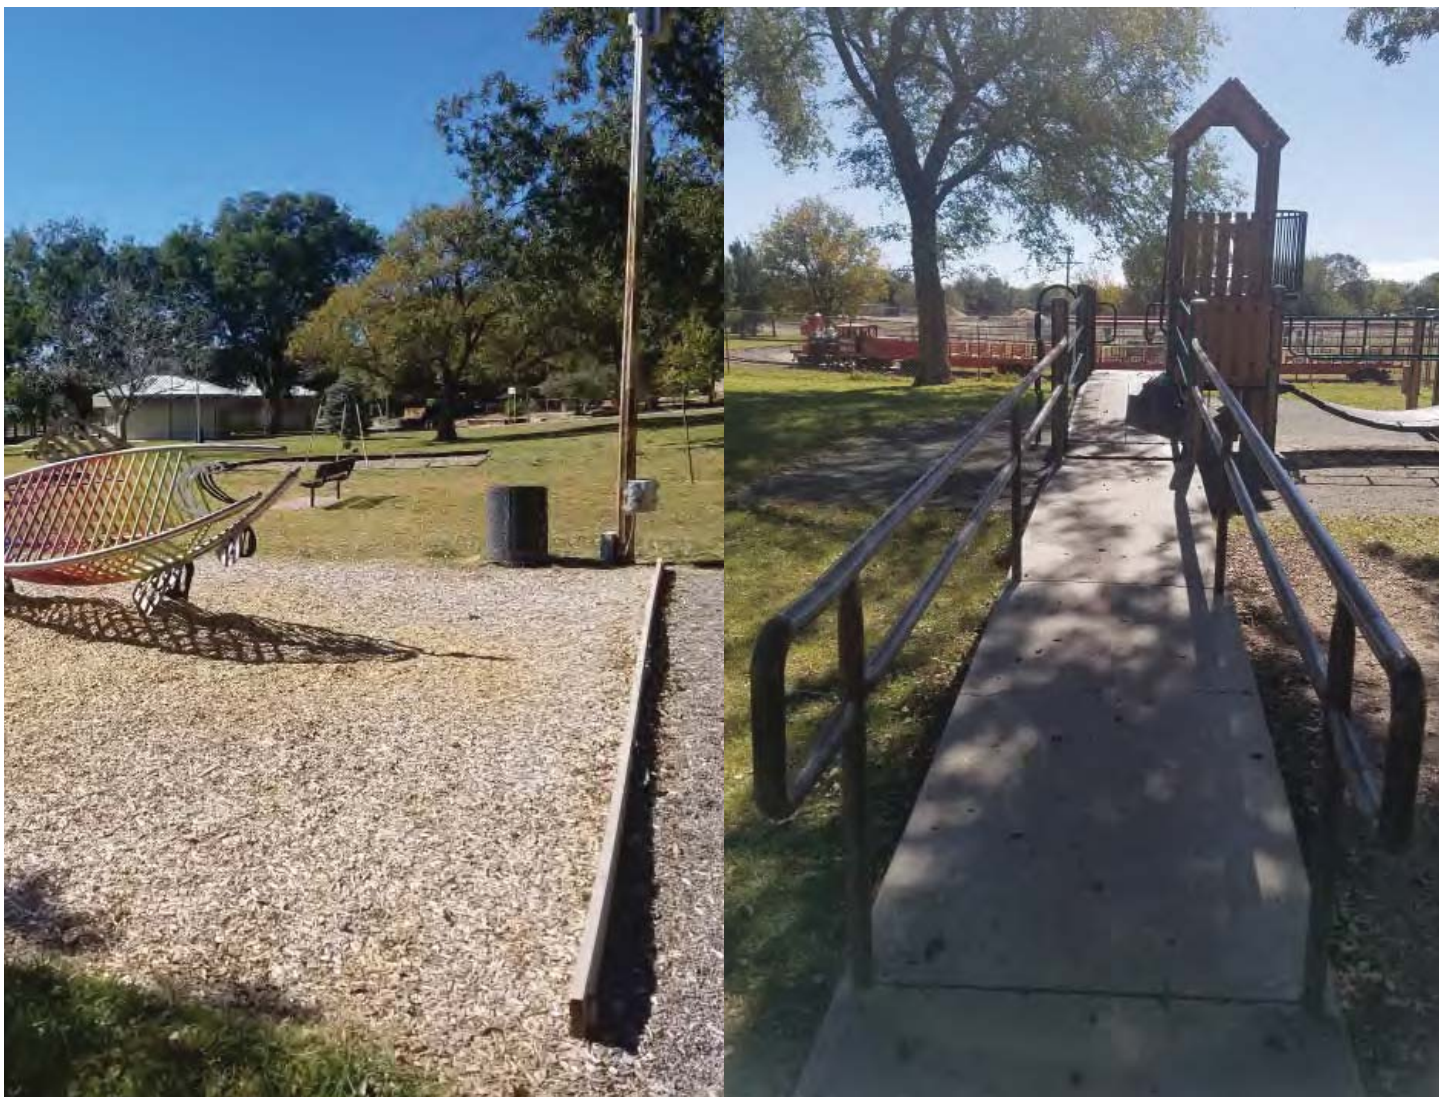
- **Fish:** The fish is a newer piece of equipment installed over engineered wood fiber with an incomplete lumber border. The elevation of the equipment in relationship to the surrounding grade does not allow for the engineered wood fiber to be maintained at the proper depth. The footing and support structure of the equipment is exposed creating a safety hazard.

No border exists around the fish to maintain the proper height of the safety surfacing. Ramp to accessible play structure does not provide access to lower portion of the playground. While a wheelchair can access the upper deck equipment, there is little for the user to do once they are there.

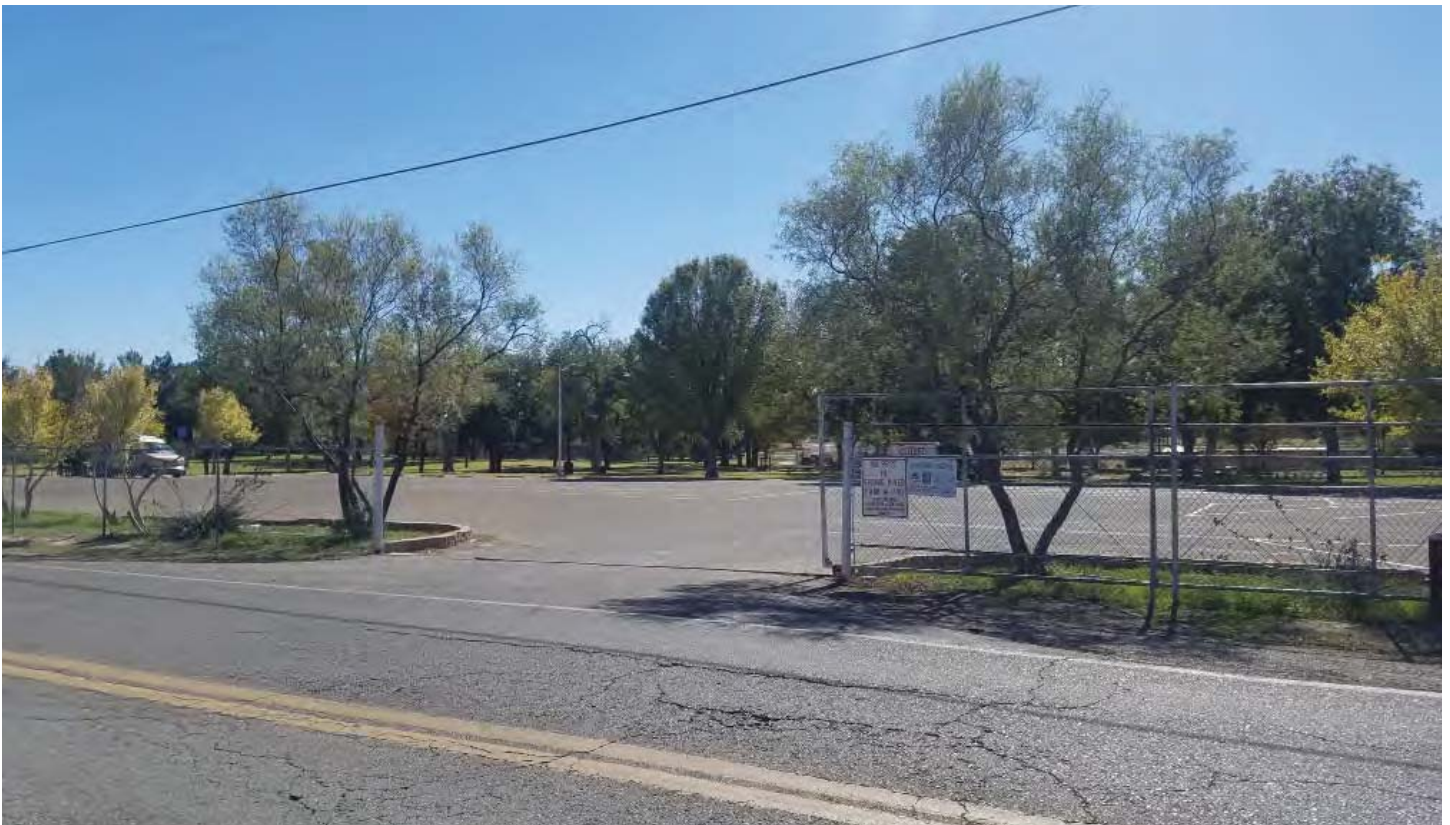
The sense of arrival to the Zoo could be improved with a themed gateway and new landscape.

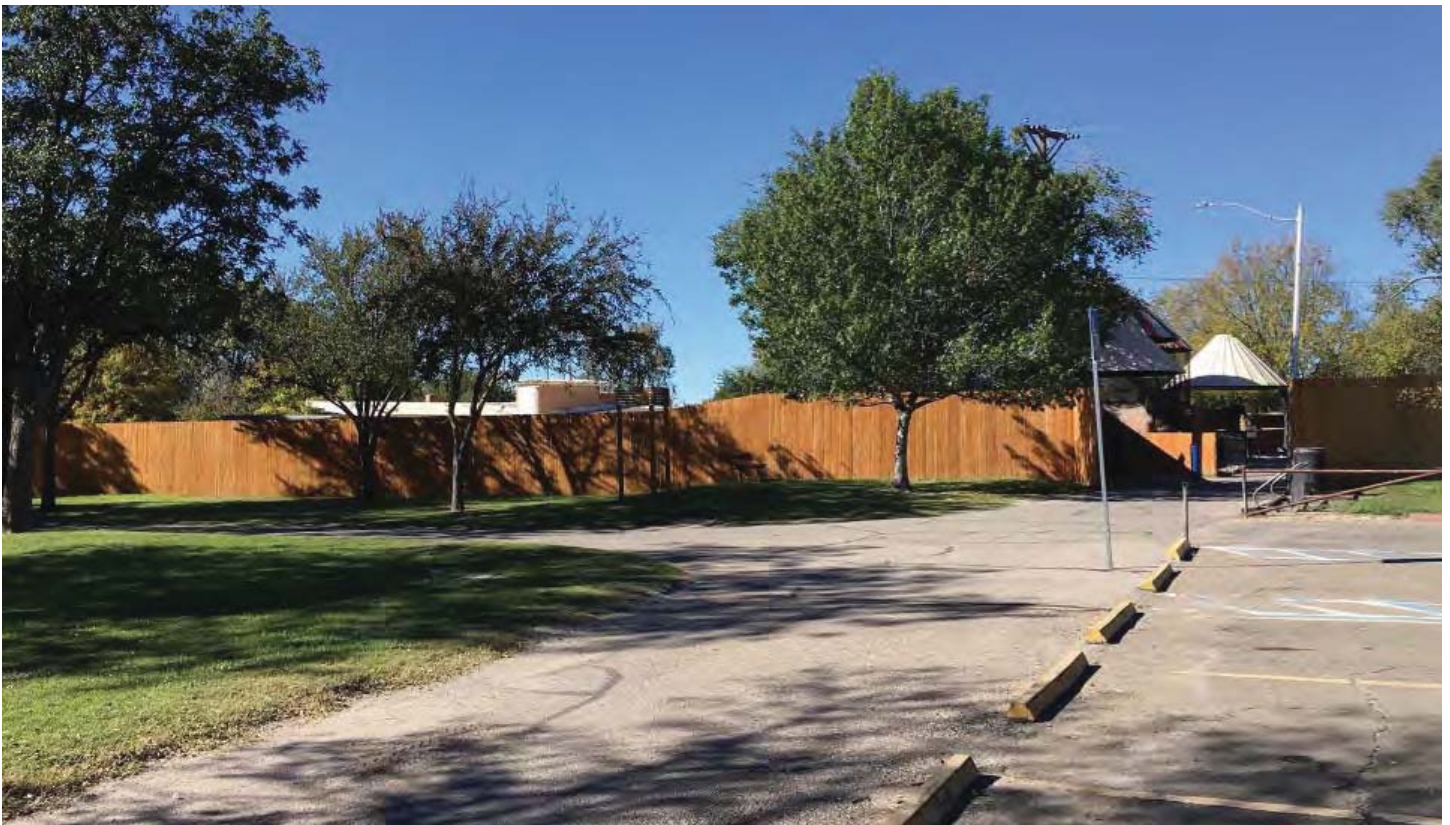
Once the visitor arrives at the Zoo proper, there is no clear direction on where to start. A wooden directional sign gives a general sense of where exhibits are located, but there is no “grand entrance” that dictates a sense that you have arrived somewhere special. The lack of a perimeter fence separating the Zoo from the rest of the park creates too many options for entry. Options for entry are to immediately start into the Capitan trail, come into the raptor and children’s area (perhaps the most distressing set of exhibits), or wander down to the concessions and carousel area. None of the available options have a “wow” factor and it is not apparent if a visitor is required to check in and pay. There is not an opportunity for a visitor to stop, orient themselves and plan their visit. There is no clear indication of where they should start their visit.

The existing entrance is confusing and does not indicate that the Zoo is a special place.

- Install a perimeter fence between the Zoo and the rest of the park, limiting entry and exit to a single point. Controlling access will allow the Zoo to charge an entry fee, collect tangible user data and begin to control the visitor experience.

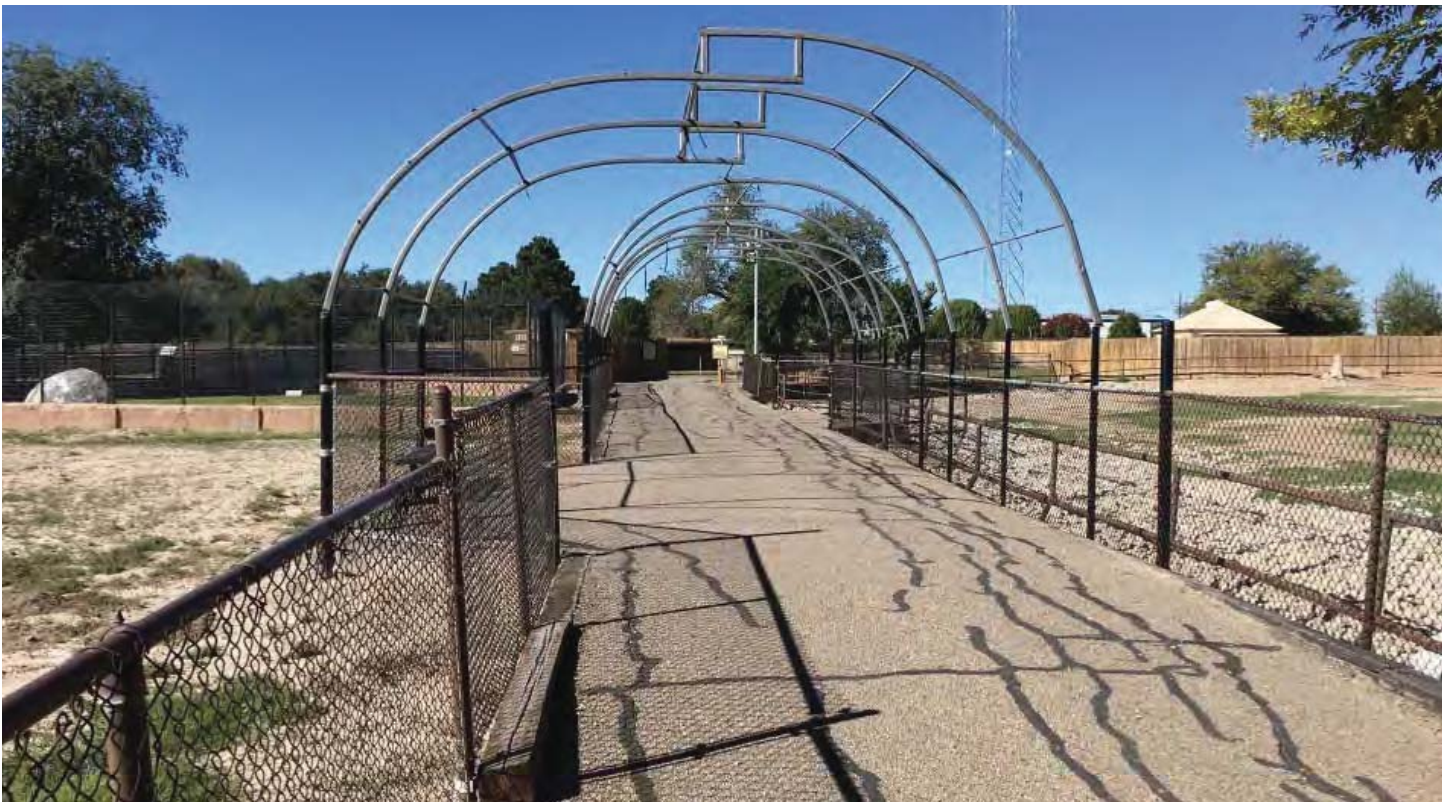
- The existing materials for visitor areas do not contribute to the theme of the Capitan Trail. There is far too much chainlink fencing and a great deal of it is in poor condition. Benches are provided, but there is little shade or space to make the seating particularly inviting, and the myriad of bench styles do not thematically relate to the Capitan Trail. The paths are primarily asphalt, which is common for zoos, but the surface is failing in several areas and needs to be replaced. The trail is elevated in several places, but the wooden retaining walls are beginning to

This picture illustrates a number of issues with the visitor experience. The straight trail and lack of screening allows portions of five or more exhibits to be seen. The entire scene is quite barren with no shade and little landscape. The cracks in the asphalt are a result of the retaining walls failing. There is far too much fencing visible, much of it in poor condition. A user's foot can slip between the path and bottom of the fence causing injury. All surfaces, whether natural or man made, are worn and give an impression of poor quality.

fail causing failure of the trail surface.

- Install landscaping and/or fencing to screen unwanted views. Unwanted views include maintenance areas, off-site buildings and other elements that detract from the Capitan Trail theme. Any visible structures should relate to the Zoo theme by using vernacular architectural styles. Existing buildings that cannot be easily screened may be candidates for cladding or other surface improvements to make them feel rustic. Where space allows, create changes in the path to screen adjacent exhibits and direct visitors attention to the animals.

- When repairing or replacing barriers, furnishings, structures or other objects, all materials visible to the visitors should contribute to the rustic Capitan Trail theme. Replace chainlink pedestrian barriers with themed barriers, like split rail fencing where appropriate. Remove unnecessary barriers, or consider only placing barriers immediately in front of exhibits rather than continuous barriers between several exhibits. Choose a limited number of site furnishing styles and use them exclusively. Site furnishing styles within a themed areas should be consistent. Repair asphalt trails and their supporting structures. Where viewing plazas are created, consider using earth toned brick pavers or flagstone to highlight the area's significance. See the materials palette section of this report for examples.

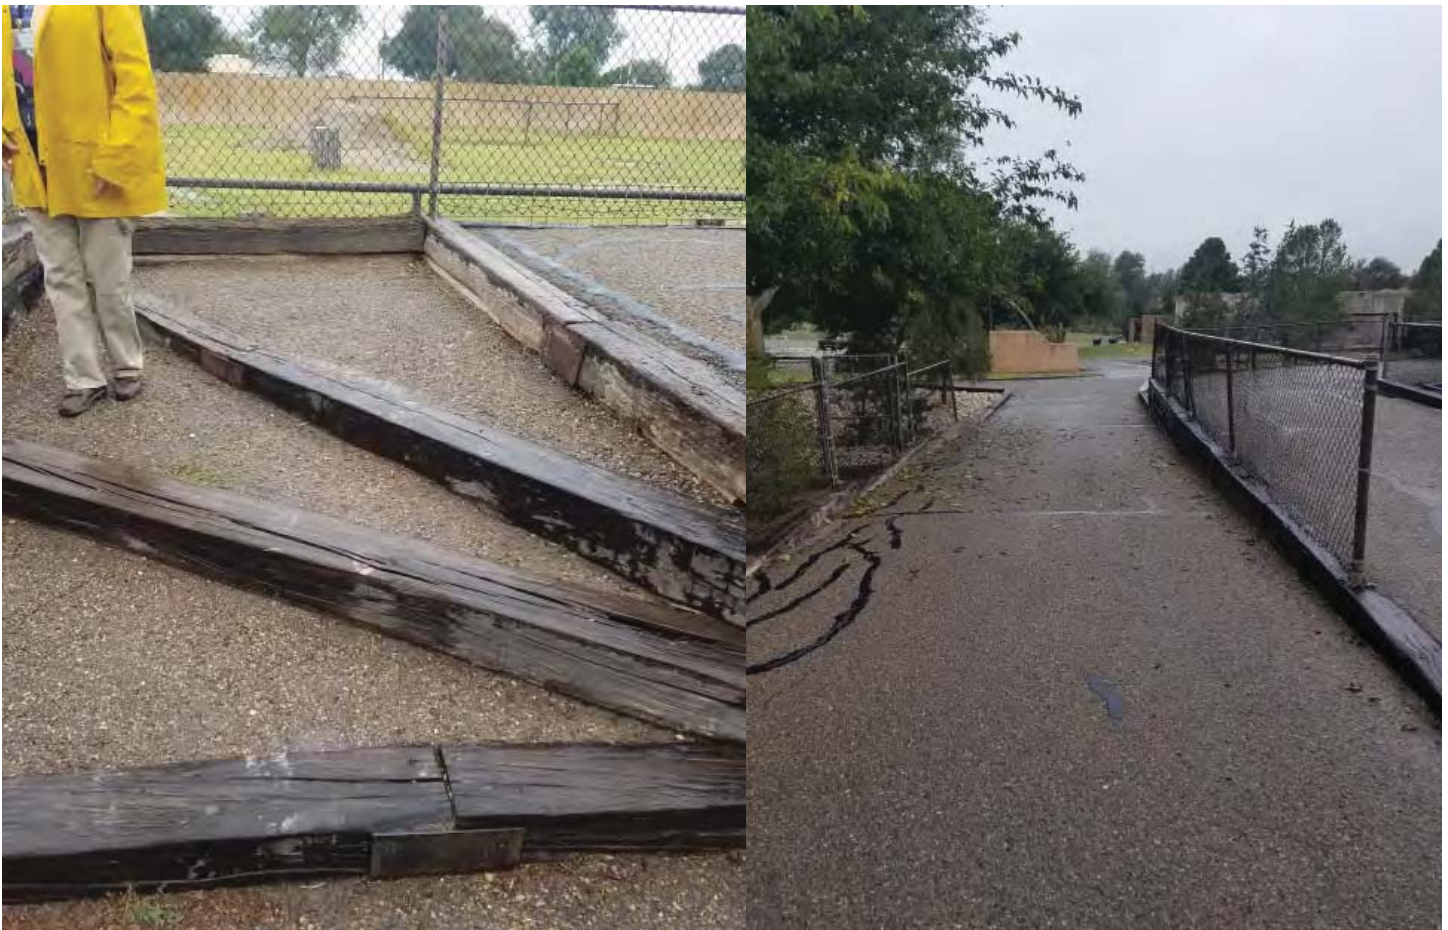
- The ramp slope appears to be greater than 4.9% which would require landings and handrails. Currently the length of the ramp exceeds the maximum distance allowed without a landing and there is a tripping hazard/drop-off at the top of the ramp.
- The alternate path to access the raised path is by stairs, which are constructed of railroad ties and asphalt. The stairs are failing and contain numerous tripping hazards.
- Neither the stairs nor the ramp have the required handrails. Accordingly, there appears to be no direct accessible path from the raised trail to the southern portion of the Zoo.

Two problematic routes prevent access between the northwest and southwest portions of the Zoo. The stairs are a significant liability for the City and a hazard for visitors.

- Verify the ramp slope. If the ramp slope is greater than 4.9%, reconstruct the ramp with landings and handrails per the current ADA accessibility guidelines. If the slope is less than 5%, it can remain in its current condition with the exception of the tripping hazard at the top of the ramp. Extend the existing chainlink barrier as required to block the hazard.
- Regardless of what happens with the ramp, the stairs should be reconstructed per current ADA accessibility guidelines.

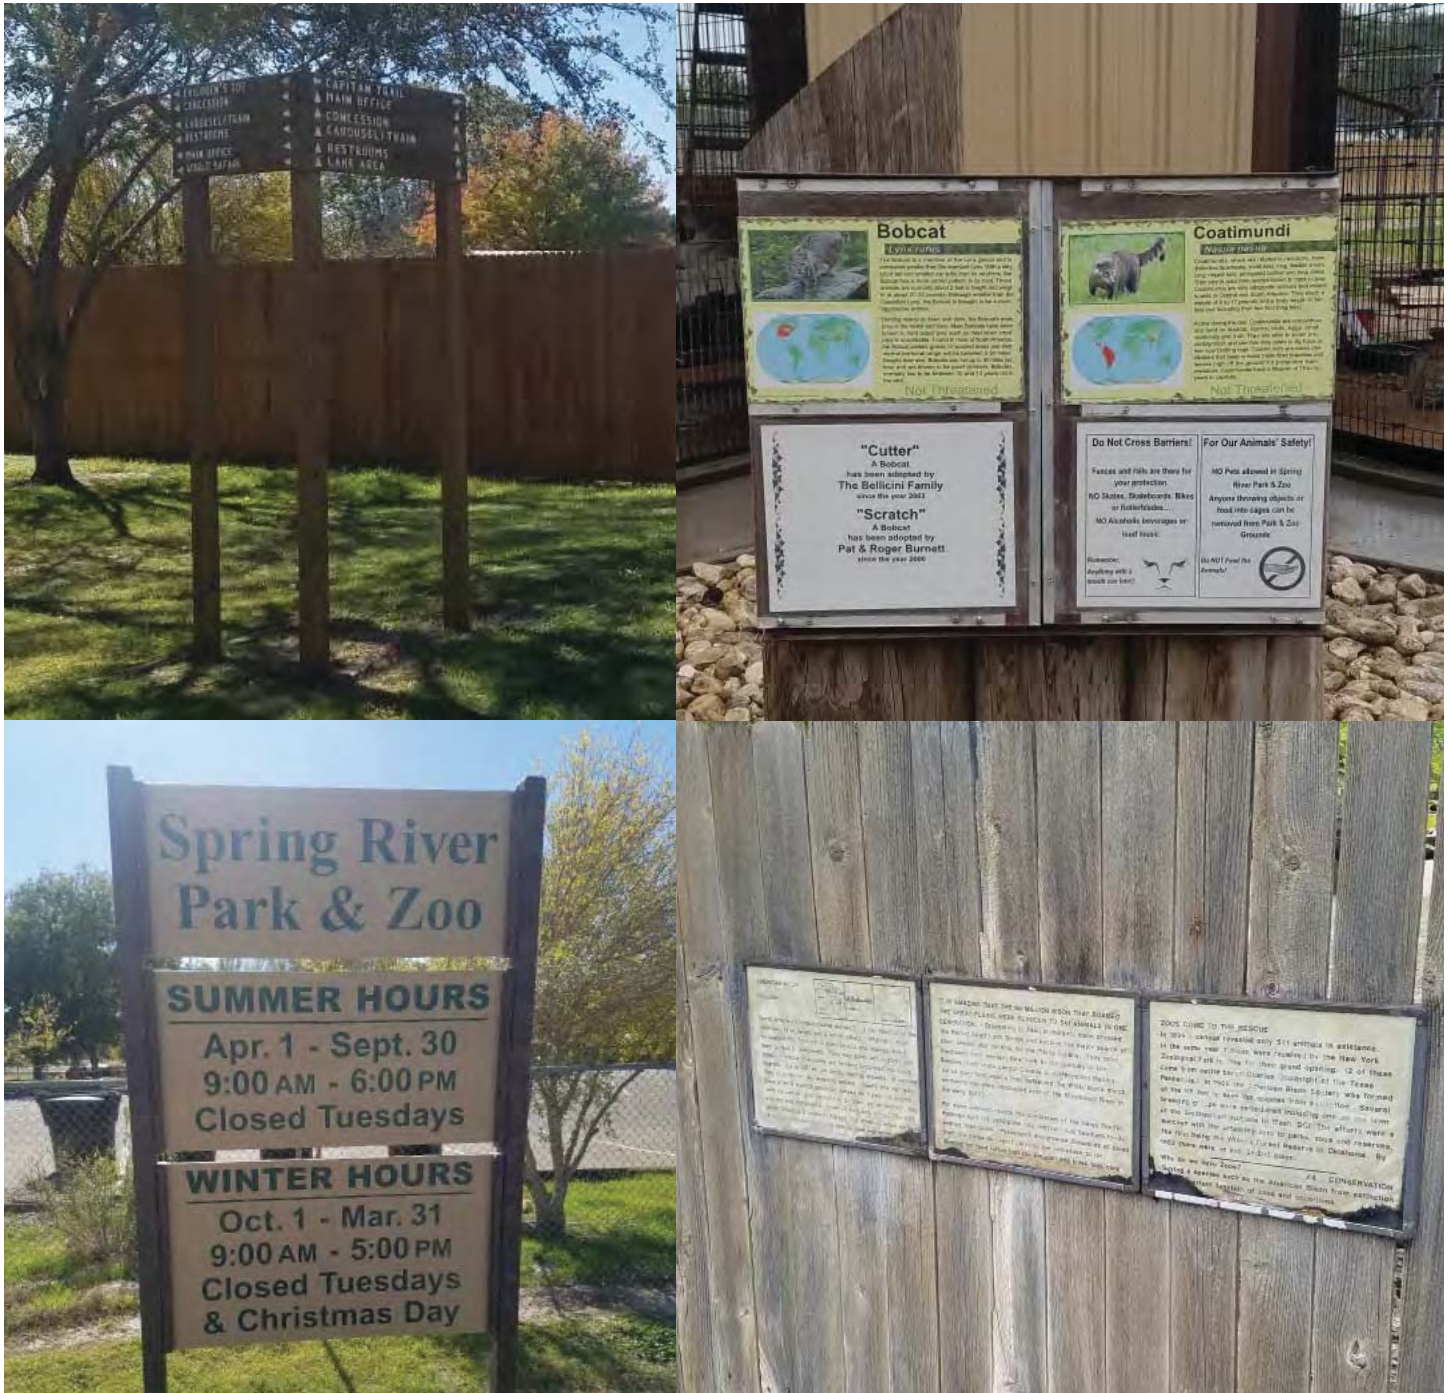
- The animal information signs are on printed paper in a plexiglass rack. The signs are inconsistent in style and in information presented, and some are missing from certain exhibits.
- Donor information is on printed computer paper in the same plexiglass rack.
- Wayfinding signage is made of heavy duty plastic or carved wood, and is placed along the County Road, the southwest corner of the parking lot and near the eagle exhibit. The signage along the road is placed parallel to the road and is not readily visible from a vehicle.

Examples of just some of the different sign types at the Spring River Zoo.

- Signage is an important detail that can confer a sense of organization, consistency and quality if done correctly. Animal Information and Donor Signs should be replaced with exterior grade laminate signs and mounted on a secure base. These signs should include Spanish translations.
- Wayfinding Signage should be redesigned to support the rustic Capitan Trail theme and should be of a consistent style throughout the facility. Wayfinding Signage should include; a monument sign at the corner of East College Blvd and North Atkinson Ave, a parking sign at the entrance to the parking lot, hours and admission information at the Zoo entrance, and directional signage as needed throughout the facility.

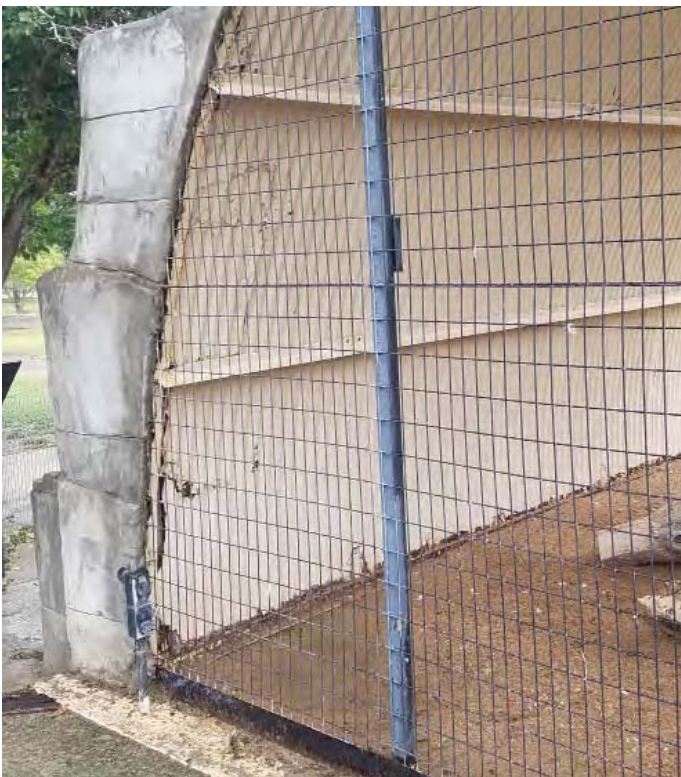
- The eagle exhibit is outdated and appears to be structurally failing.
- The exhibits in the children's area (raptors, beavers, etc.) are too small and poorly designed.

The eagle exhibit is beginning to fail structurally.

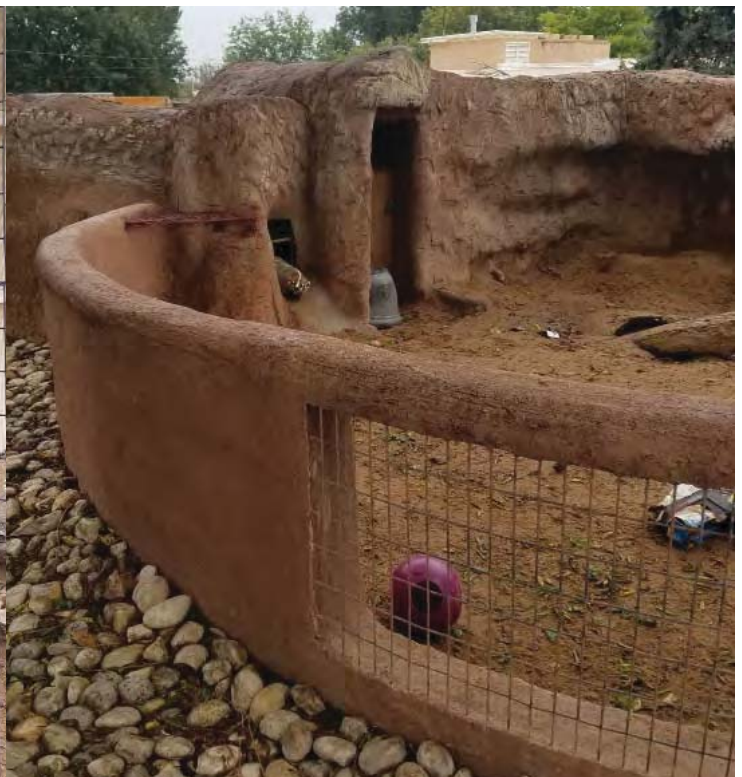
Staff access to the badger exhibit is very difficult.

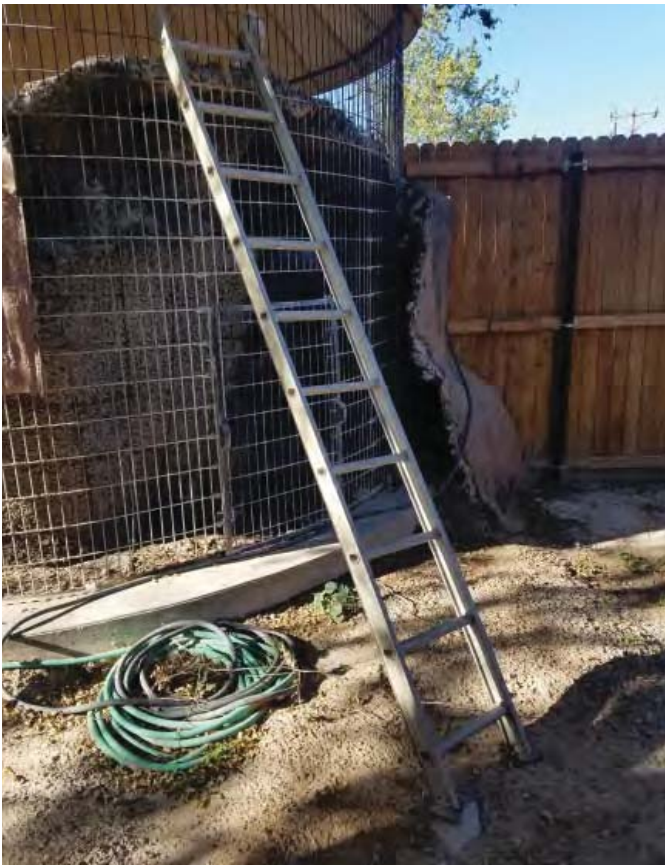
Behlen cage exhibits are difficult to clean.

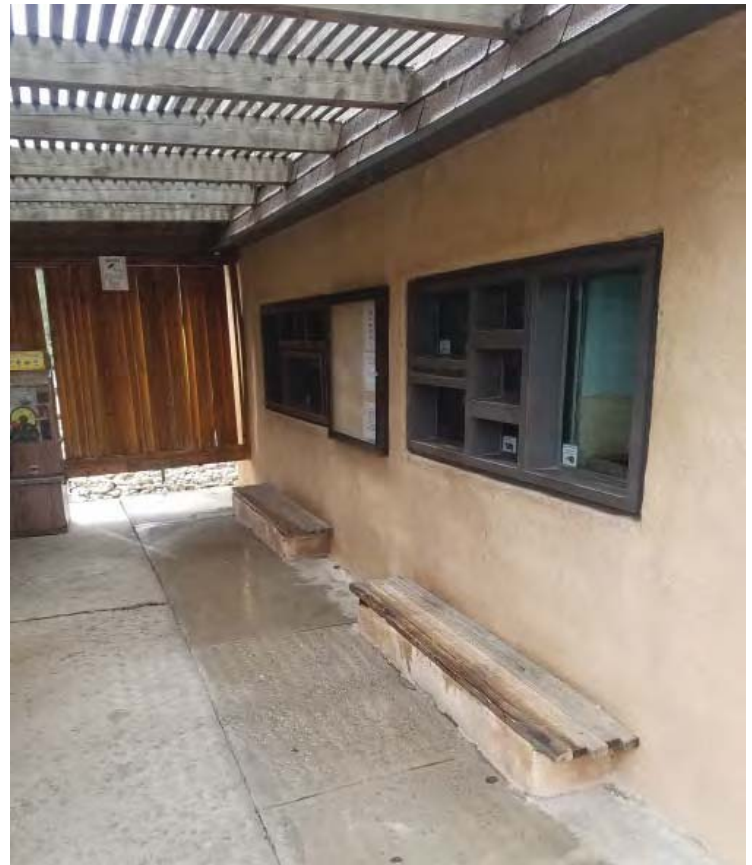
Reptile house is problematic for staff, visitors and the animals.

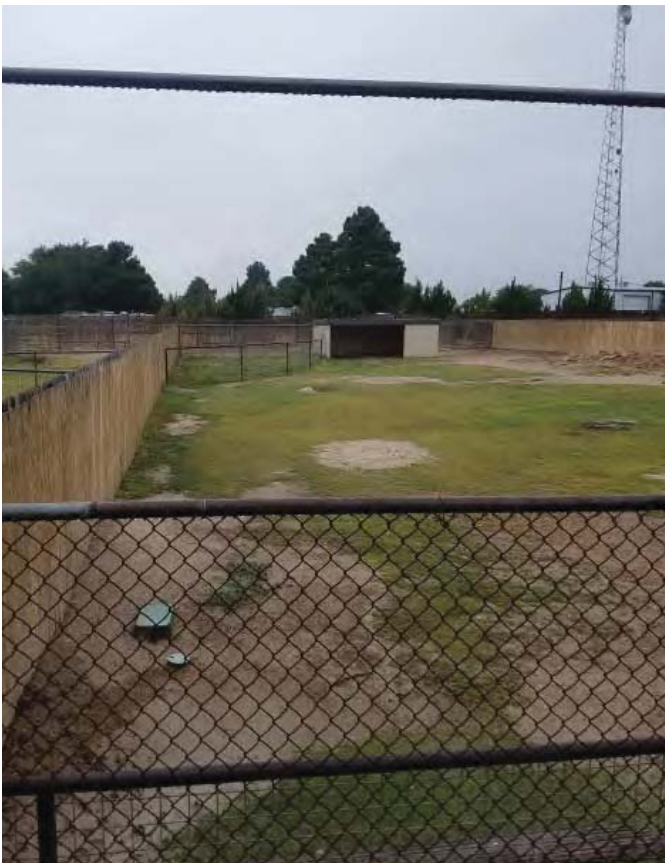
Narrow, deep enclosures with the night house in the center is not preferred. Wide, shallow exhibits with a concealed night house provide a better viewing experience for visitors.

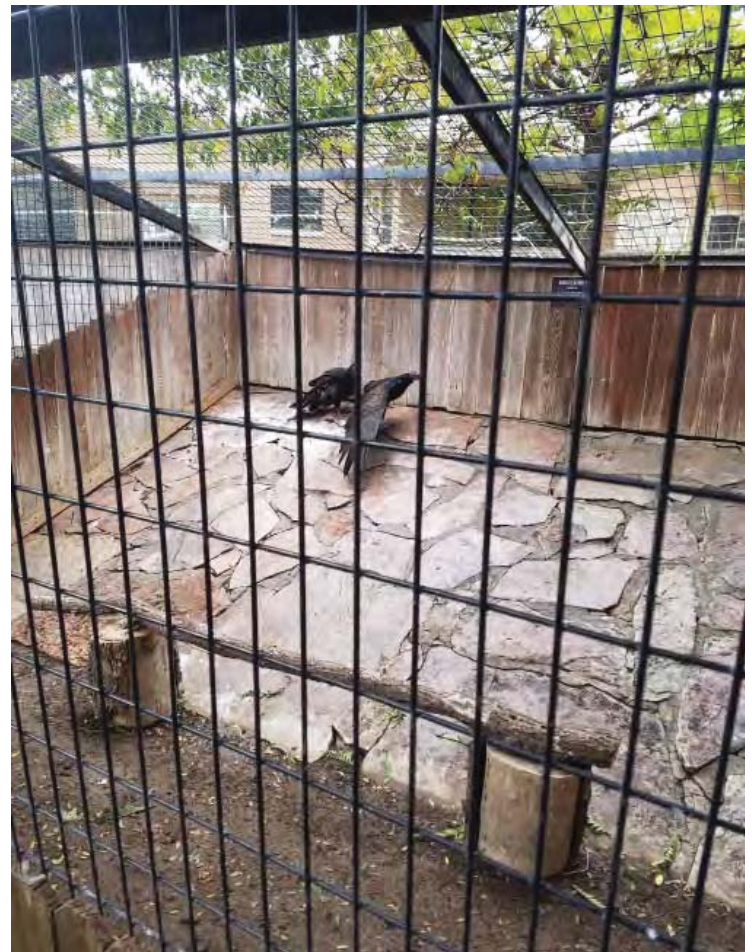
Design of raptor cages is very concerning.

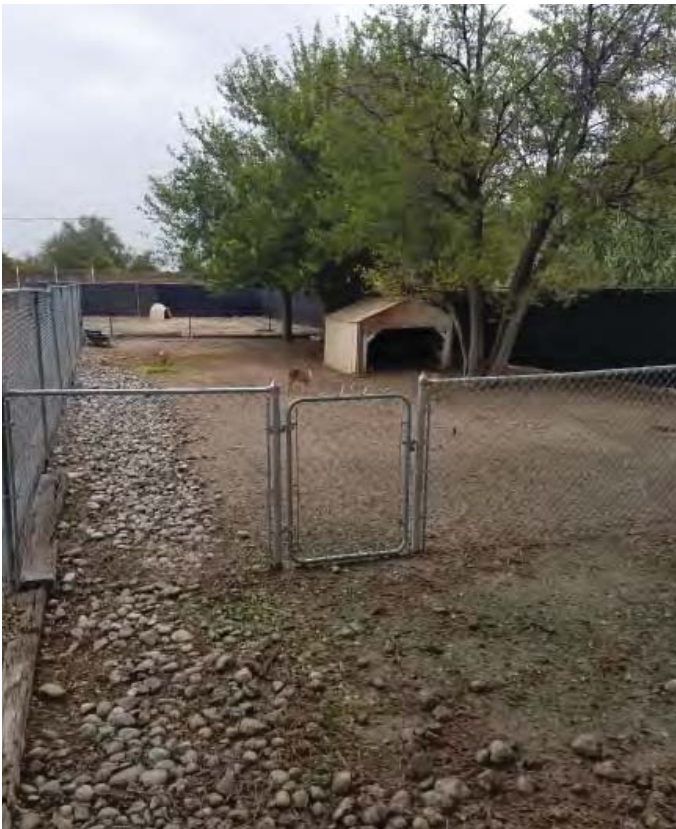
Use of chainlink, storage sheds and residential objects is poorly perceived by the public.
